April 29, 2005

EIFS System Evaluation

**Property Address
Any Town USA**

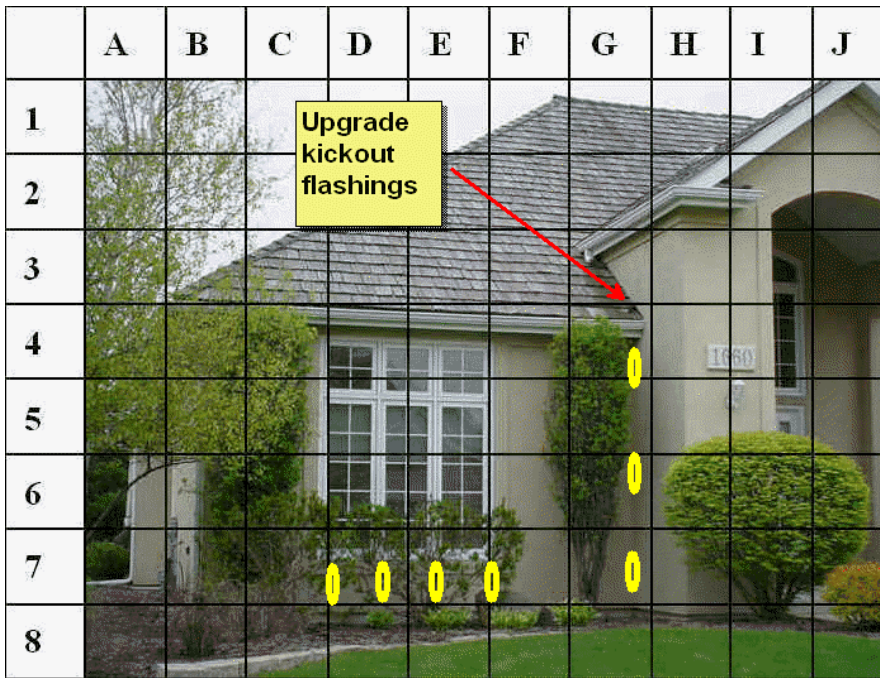
Grid Location	Item Description	Moisture Readings	Substrate Condition	Observations	
D7L	Windows	21	Firm		
D7R	Windows	7.9	Firm		
E7	Windows	8.6	Firm		
F7	Windows	7.9	Firm		
G4	Kickout	6.9	Firm		
G6	Kickout	6.0	Firm		
G7	Kickout	7.1	Firm

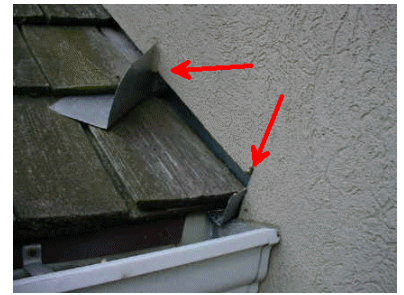
Improper kickout flashings. Replace all to current std.

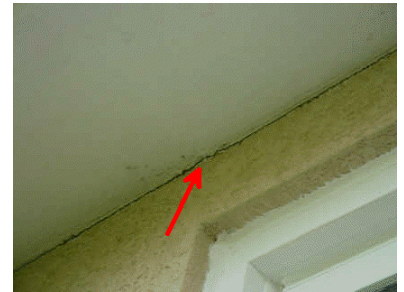
Gaps at the soffit should be sealed.

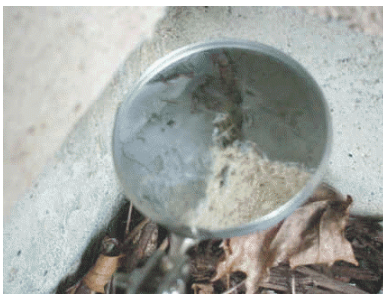
Yellow mesh is visible at terminations. (STO system)

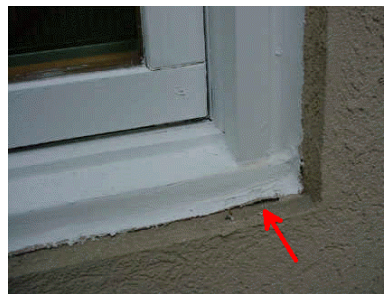
Perimeter sealants have aged and need replacing.

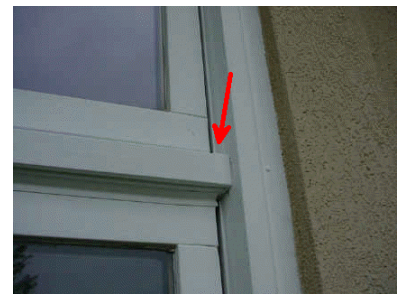
All wood window construction joints need to be sealed.

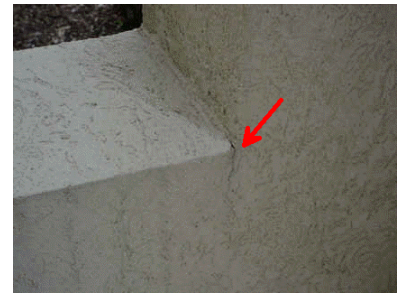
Repair cracking at corners on flat surfaces.

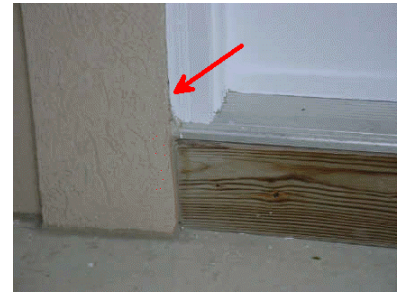
Replace all aged sealants

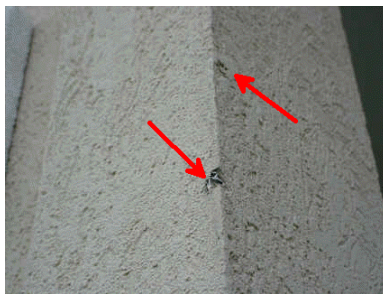
Repair all damage to EIFS corners.

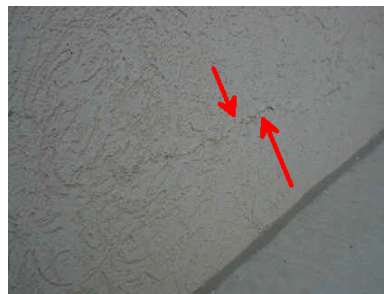
Repair compression cracking at entrance.

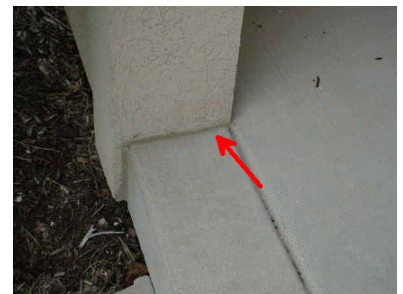
Seal or reseal EIFS to dissimilar materials.

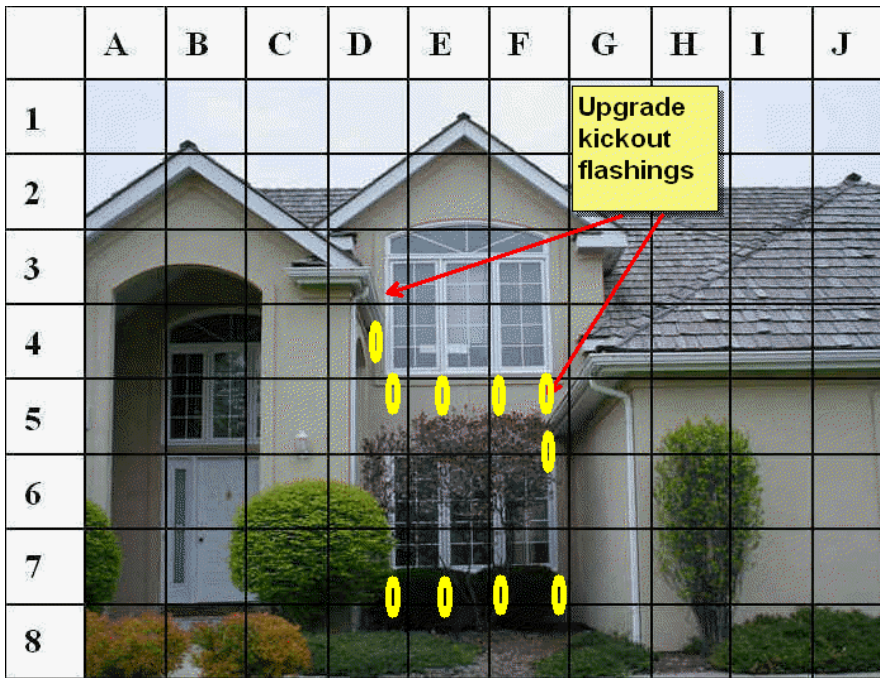
Grid Location	Item Description	Moisture Readings	Substrate Condition	Observations	
D4	Kickout	40	Soft		
D5	Windows	40	Firm		
E5	Windows	8.6	Firm		
F5L	Windows	9.1	Firm		
F5R	Windows	10.1	Soft		
D7	Windows	40	Soft		
E7	Windows	7.8	Firm		
F7L	Windows	7.7	Firm		
F7R	Windows	8.0	Firm		
F5,6	Kickout	9.6	Firm

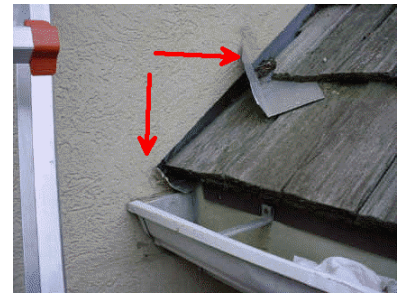
Improper kickout flashings. Replace all to current std.

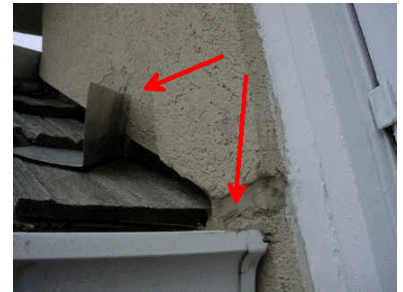
Improper and missing kickout flashing. Replace all.

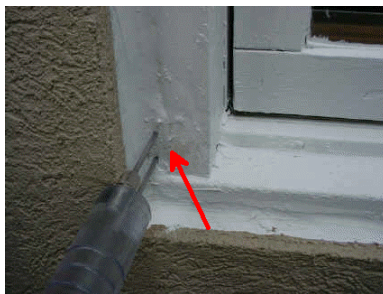
Rotted wood needs to be replaced.

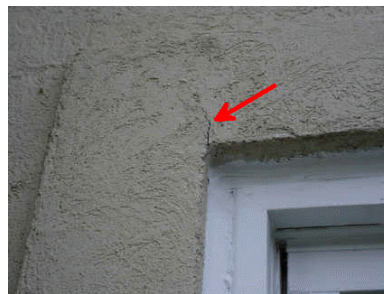
Cracking may be a result of the underlying damage.

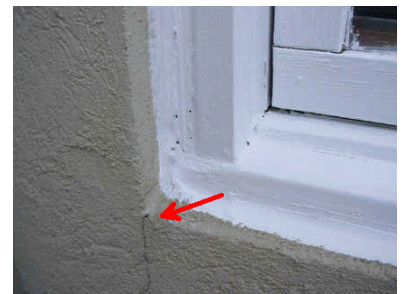
Cracking may be a result of the underlying damage.

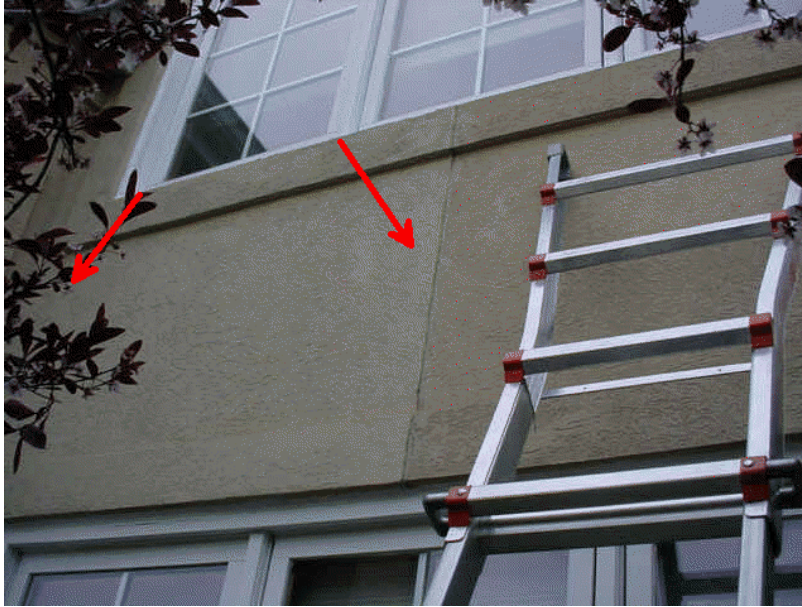
Past repair work.

We noted the past repair work did not replace the finished surfaces to match. In our opinion this is not a professional repair. The left side of this photo is currently in need of repairs again.

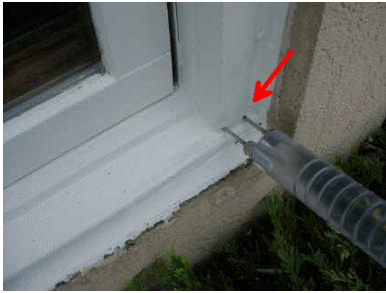
Replace all rotted wood.

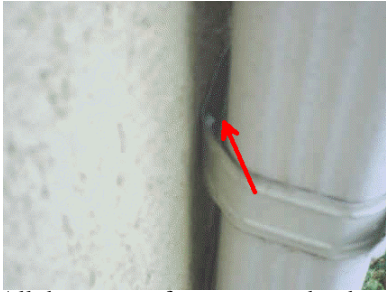
All downspout fasteners need to be sealed.

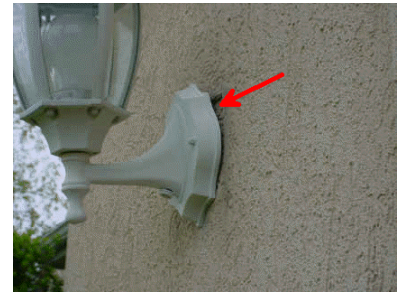
Light fixtures need to be secured and properly sealed.

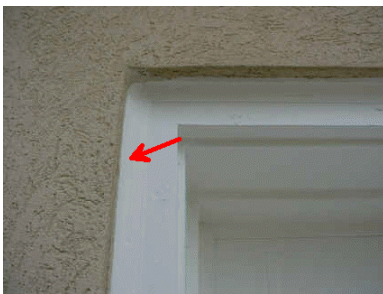
Paint hides aged sealants. Time to replace all perimeter sealants.

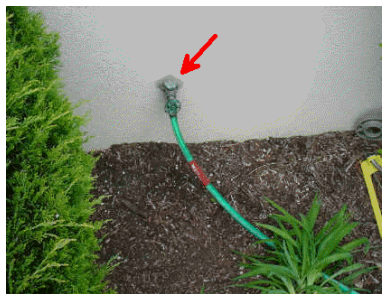
Replace sealants at piping penetrations.

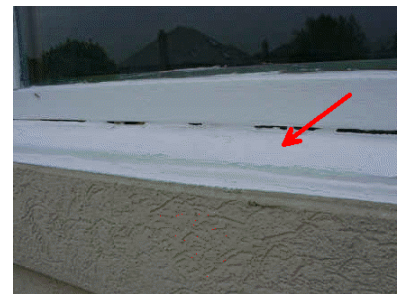
Rotted window sills need to be replaced.

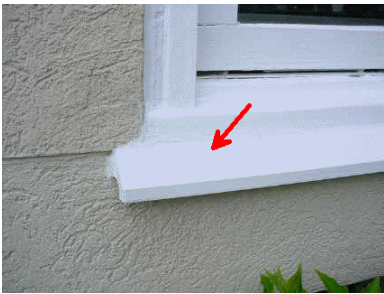
Sill vent flashing appears properly installed and is functioning.

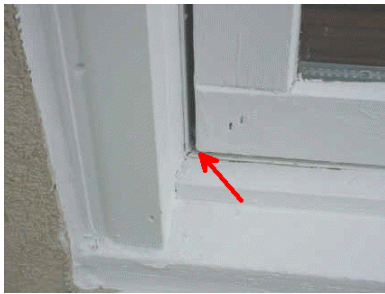
Window miter joints need to be sealed.

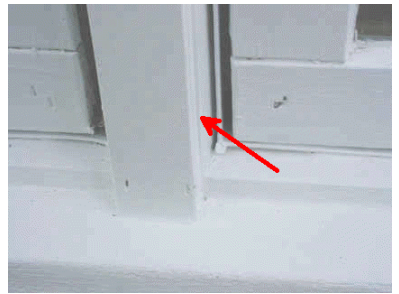
Window mullion joints need to be sealed.

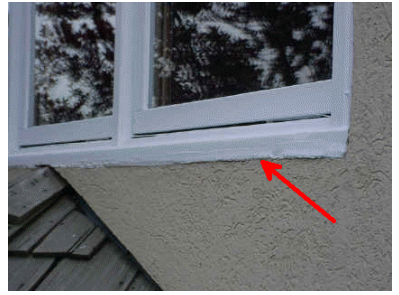
Inadequate perimeter sealants replace all.

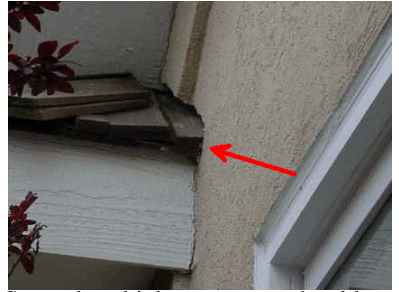
Secondary kickout returns should be installed.

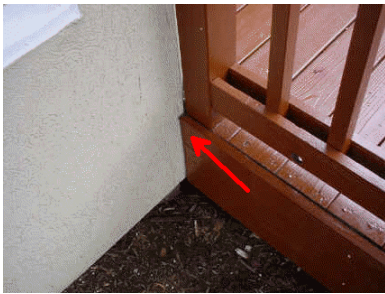
The deck is attached and sealed to the EIFS.

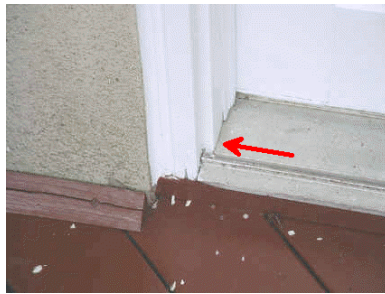
Suggest sealing door thresholds.

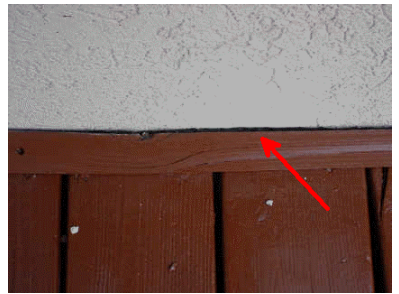
The deck diverter flashing needs to be resealed.

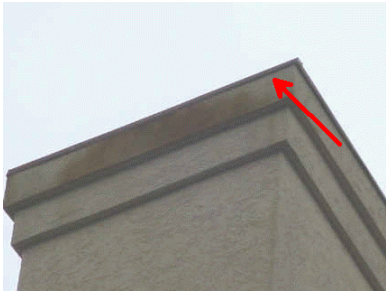
Seal the chimney cap and all it's fasteners.

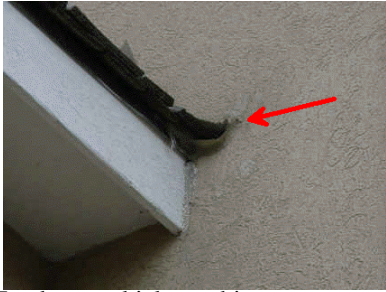
Inadequate kickout chimney flashing. Replace.

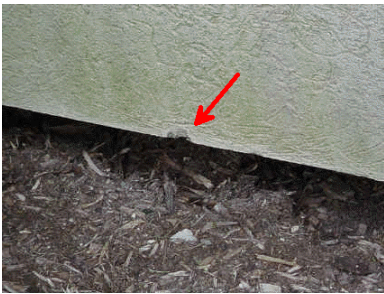
Repair typical mower damage.

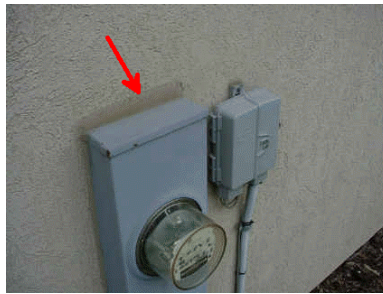
Reseal all utilities.

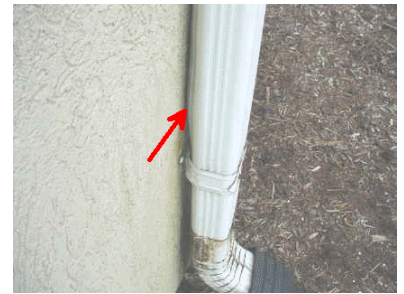
Gutter is damaged from winter freeze. Repair and seal.
