April 29, 2005

EIFS System Evaluation

**Property Address
Any Town USA**

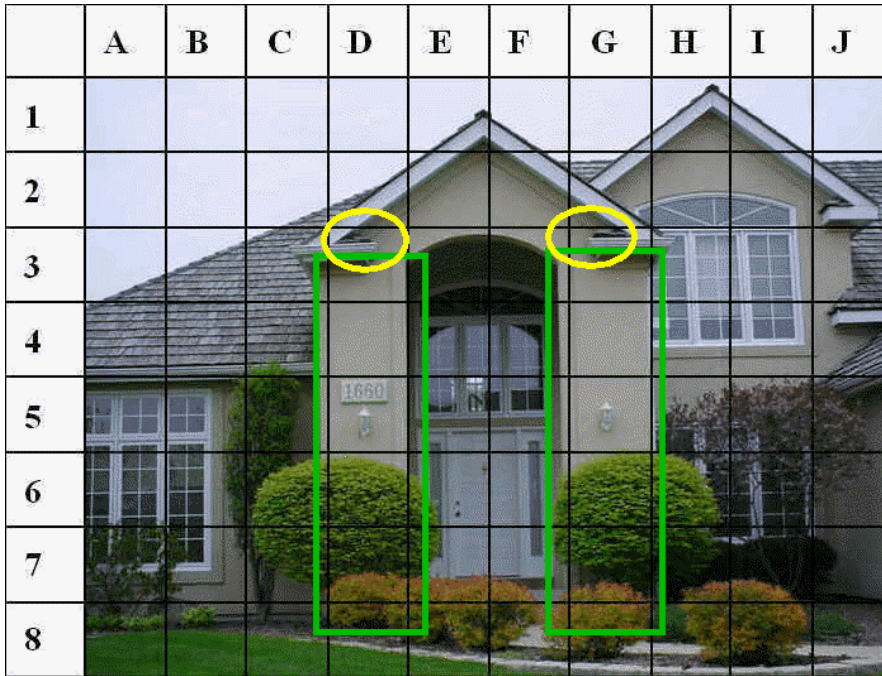
Grid Location	Item Description	Moisture Readings	Substrate Condition	Observations	
D7L	Windows	21	Firm		
D7R	Windows	7.9	Firm		
E7	Windows	8.6	Firm		
F7	Windows	7.9	Firm		
G4	Kickout	6.9	Firm		
G6	Kickout	6.0	Firm		
G7	Kickout	7.1	Firm

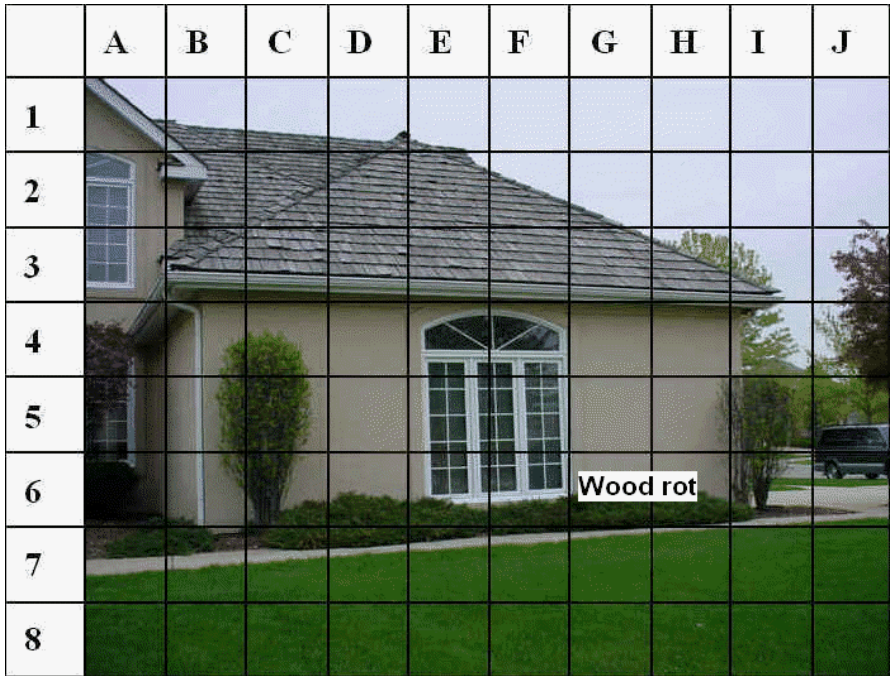
Grid Location	Item Description	Moisture Readings	Substrate Condition	Observations	
D4	Kickout	40	Soft		
D5	Windows	40	Firm		
E5	Windows	8.6	Firm		
F5L	Windows	9.1	Firm		
F5R	Windows	10.1	Soft		
D7	Windows	40	Soft		
E7	Windows	7.8	Firm		
F7L	Windows	7.7	Firm		
F7R	Windows	8.0	Firm		
F5,6	Kickout	9.6	Firm

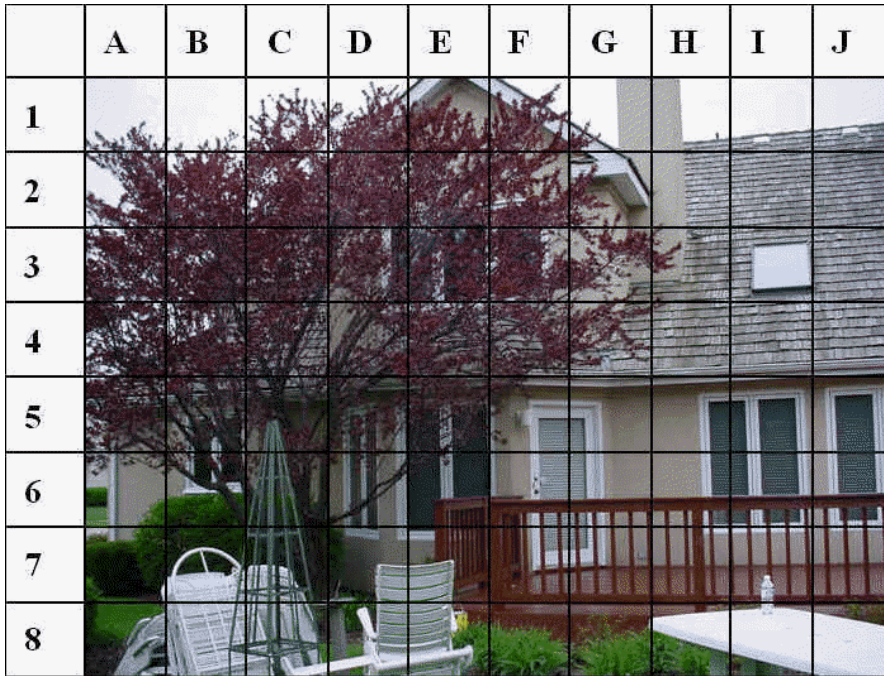
Grid Location	Item Description	Moisture Readings	Substrate Condition	Observations	
				No elevated moisture readings found on this elevation. Photo for reference only.

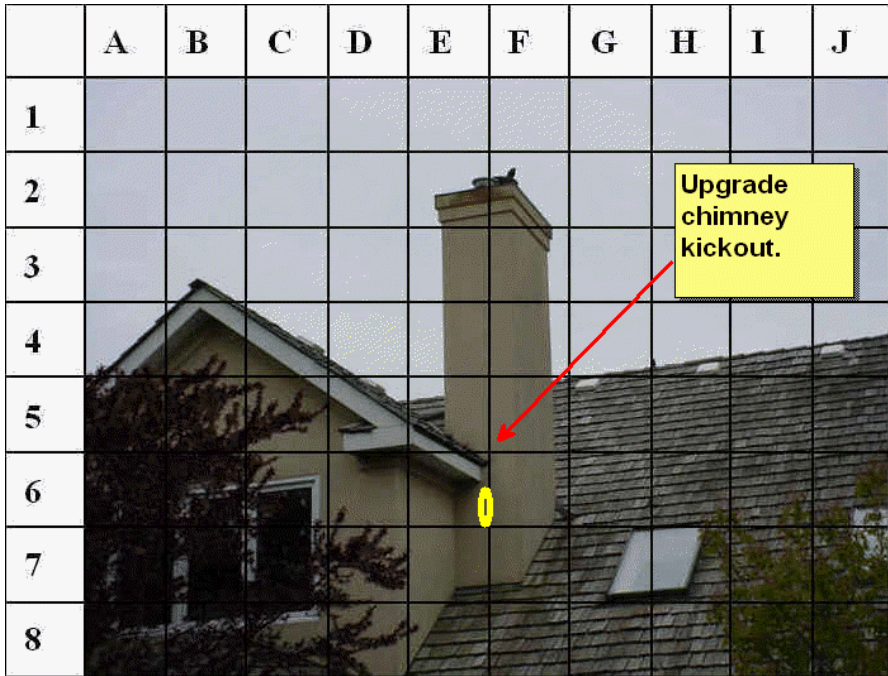
Grid Location	Item Description	Moisture Readings	Substrate Condition	Observations
				No elevated moisture readings found on this elevation. Photo for reference only.
